## GA-221-2019

### CAUSES, PREVENTION, AND REPAIR OF JOINT RIDGING AND CENTERLINE CRACKING

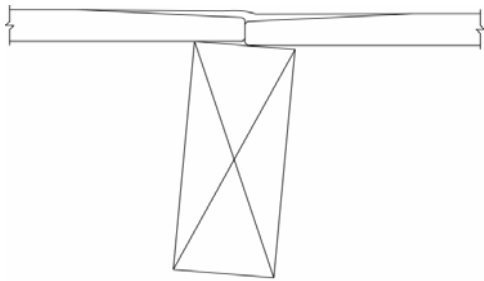
Ridging can result from the gypsum panel joint being forced together due to wood framing members shrinking. Centerline cracking can result from stress being exerted on the gypsum panel joints due to wood framing members swelling or shrinking from exposure to periods of high or low temperature and humidity fluctuations.

**Typical Ridge From  
Warped/Misaligned Framing**

Inspect framing for warped or twisted studs, proper alignment, and proper spacing to identify areas with the potential for ridging or cracking. Proper procedures and workmanship during installation of framing and during installation of gypsum panels will minimize issues due to misaligned framing.

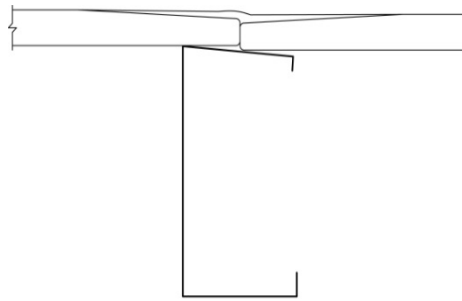
**Typical Ridge From Bent Framing**
